# Inspection Report

**Property Address:**  
123 Anystreet  
Hometown MI 44444

## Up Close Home Inspection

<b>Date:</b> 5/6/2015	<b>Time:</b> 01:00 PM	<b>Report ID:</b> 15-050601
<b>Property:</b> 123 Anystreet Hometown MI 44444	<b>Customer:</b> Mr. and Mrs. Joe Sample	<b>Real Estate Professional:</b> Bob Realtor Real Estate Company

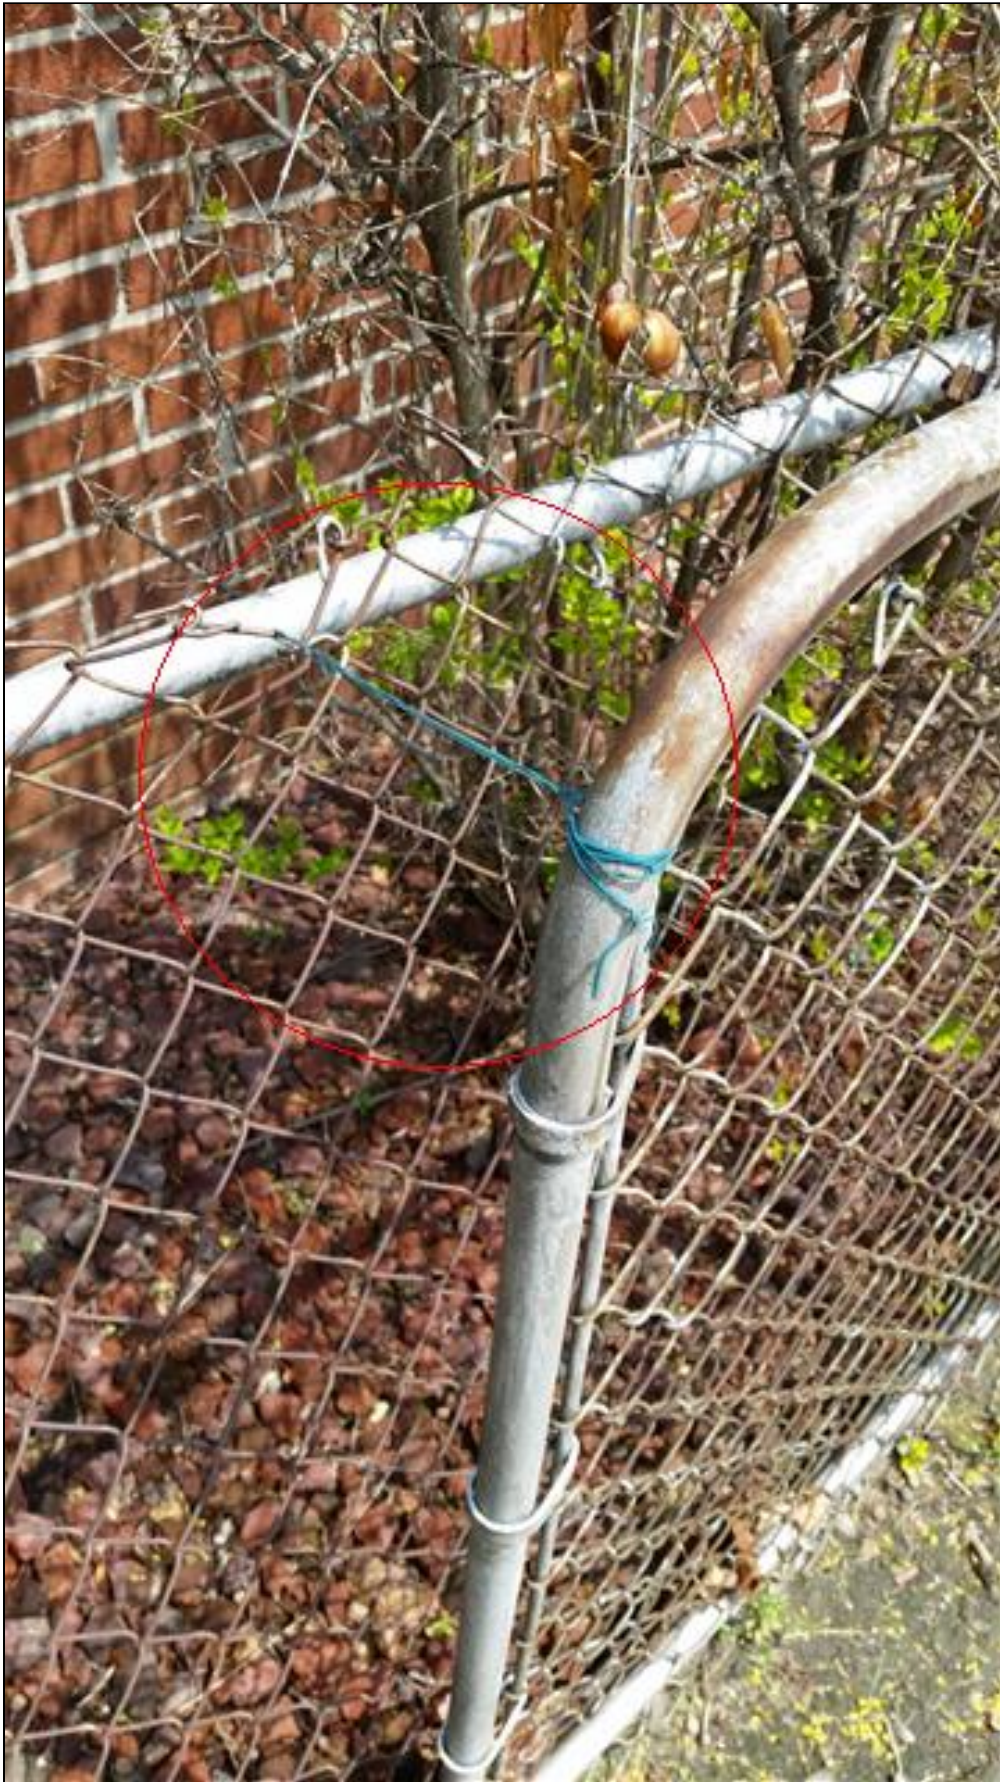
**2.5** North portion of driveway gate is fastened to the fence. Inspector did not loosen this fastening.

2.5 Item 1(Picture) North portion of driveway gate is fastened to the fence.

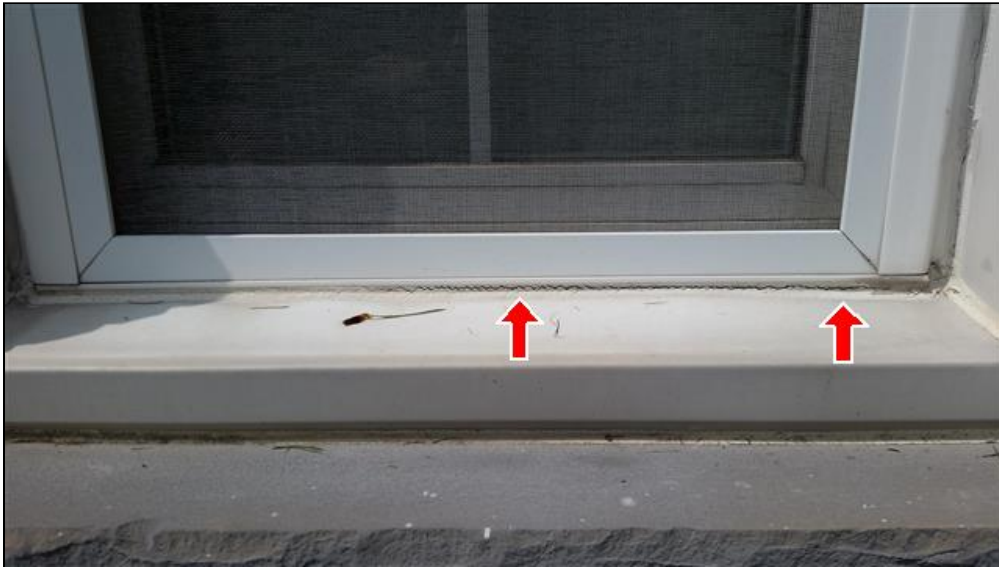
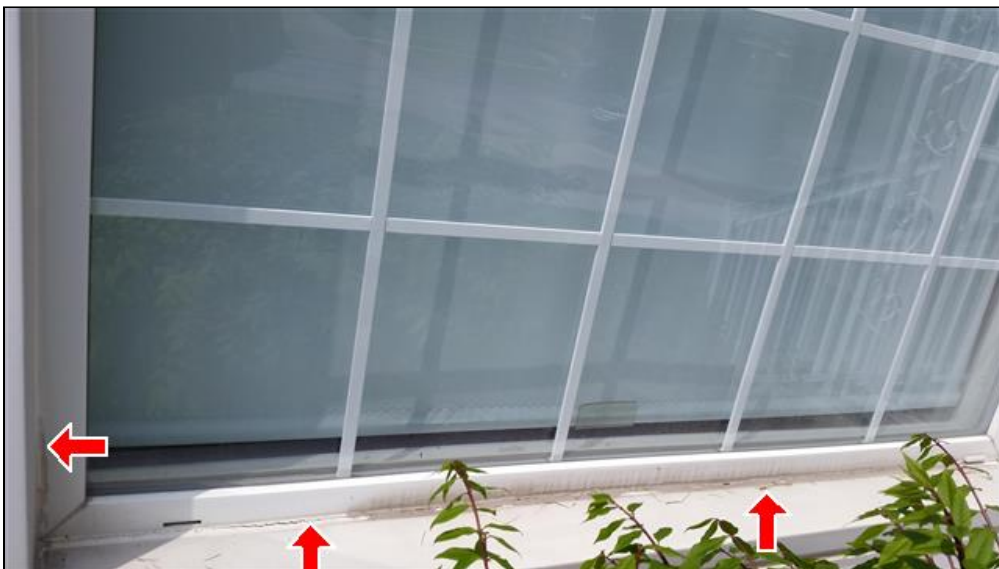
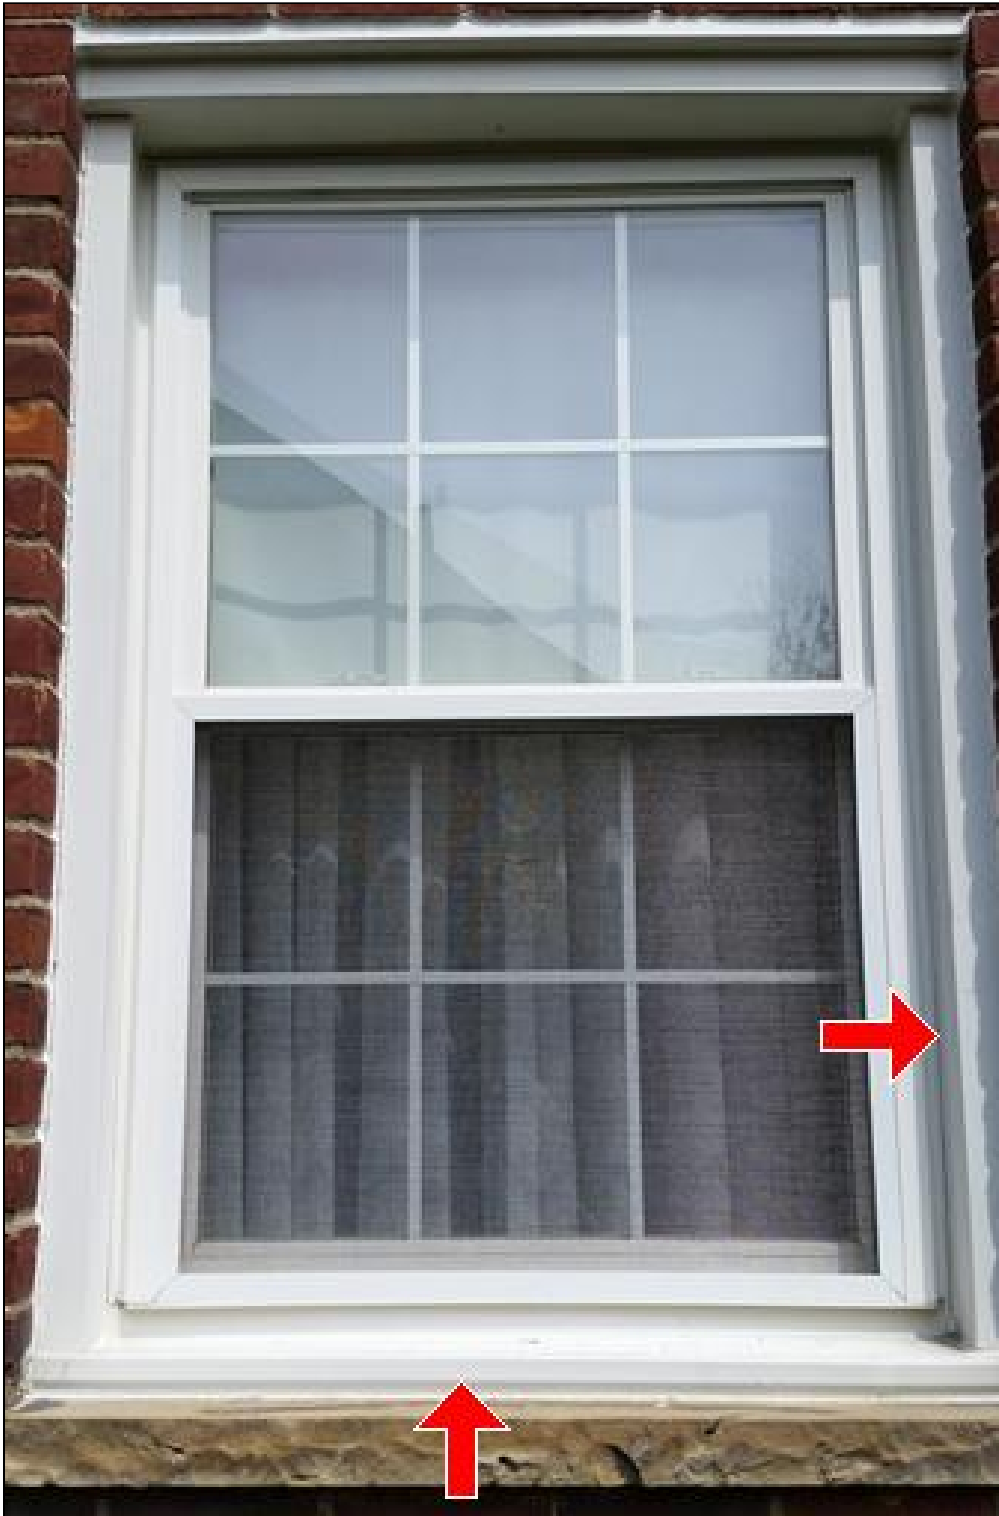
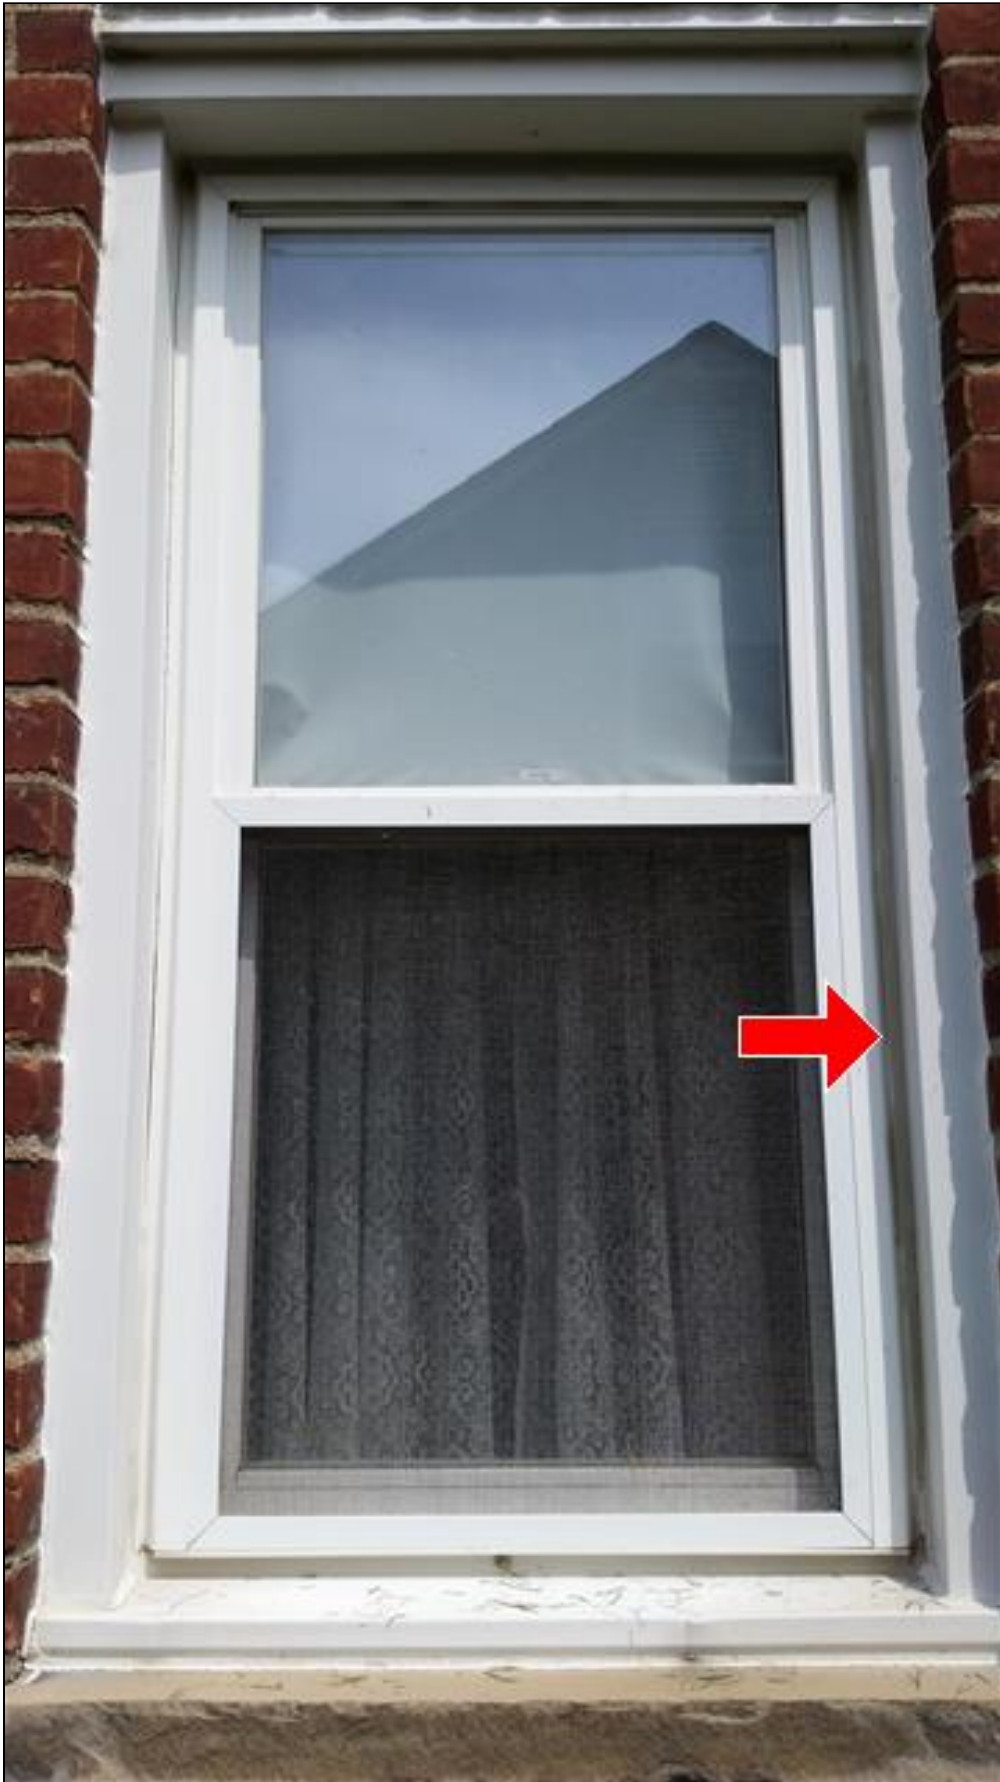
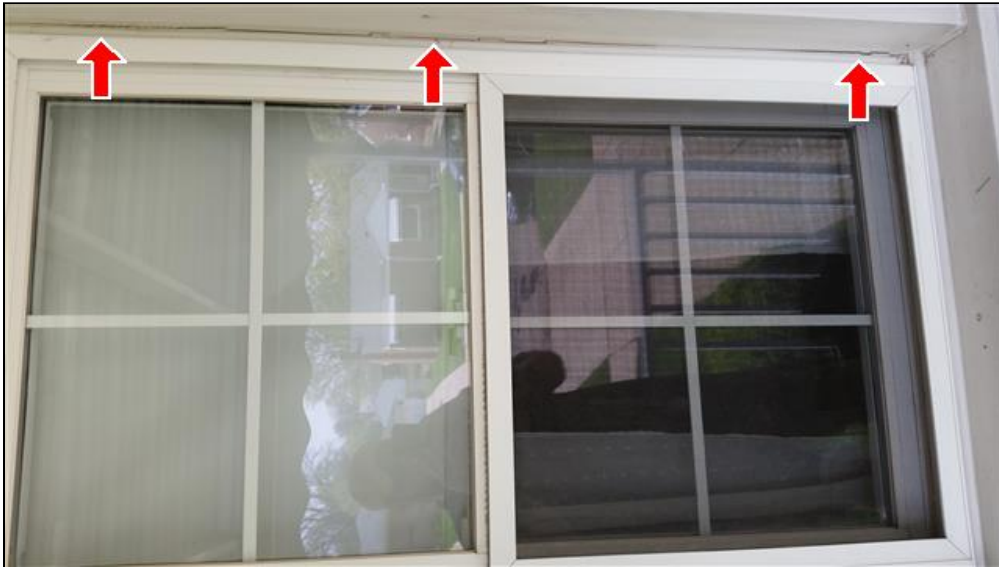
**2.7** Window seals are somewhat deteriorated. Maintenance is suggested to keep the windows in their current good condition. Window seals are somewhat deteriorated.

2.7 Item 1(Picture) Window seals are somewhat deteriorated.

2.7 Item 2(Picture) Window seals are somewhat deteriorated.

2.7 Item 3(Picture) Window seals are somewhat deteriorated.

2.7 Item 4(Picture) Window seals are somewhat deteriorated.

2.7 Item 5(Picture) Window seals are somewhat deteriorated.

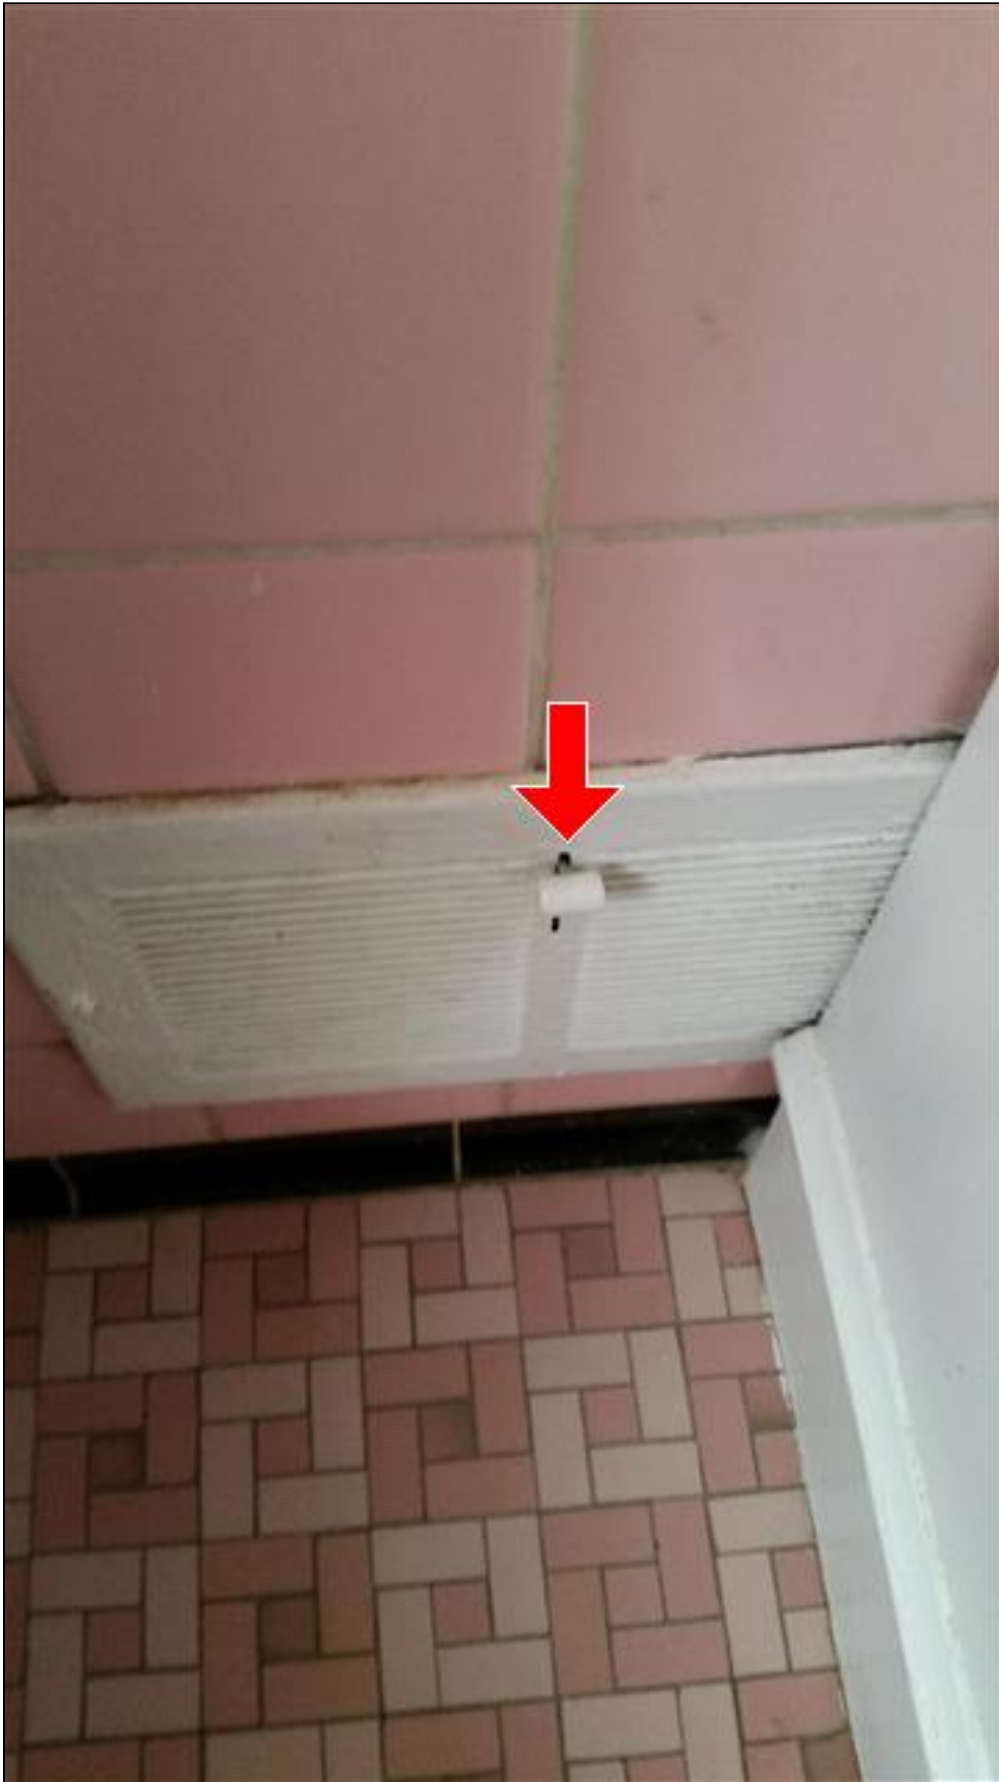
**4.3** Vent cover with adjustable damper lever is difficult to move and may require maintenance for easier operation.

4.3 Item 1(Picture) Vent cover with adjustable damper lever is difficult to move

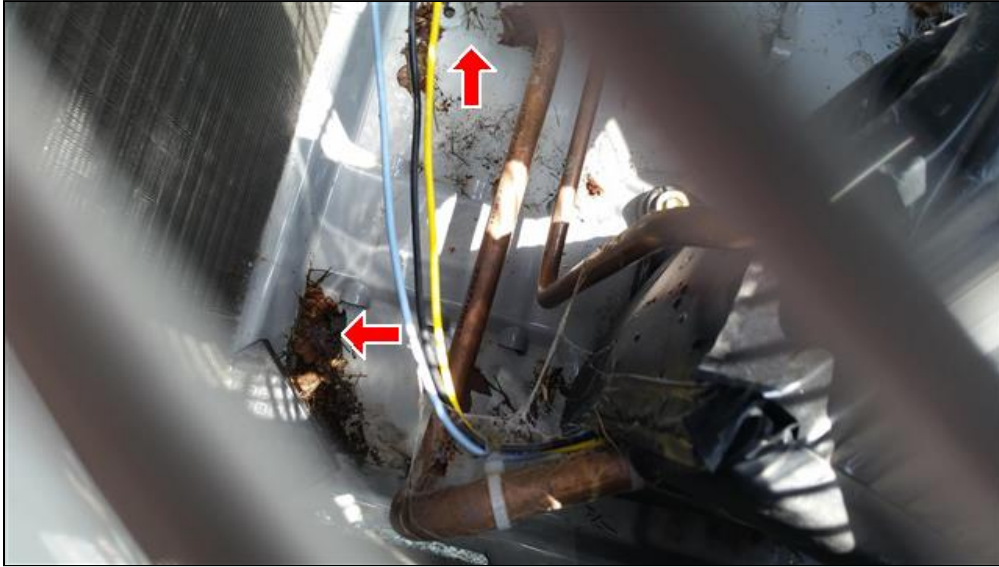
4.6 Item 2(Picture) awn debris noted in A/C unit.

(2) Lawn debris noted in A/C unit. To ensure the A/C unit stays in good condition, inspector recommends covering the a/c unit (after ensuring the unit is not running) with a tarp while cutting the grass.

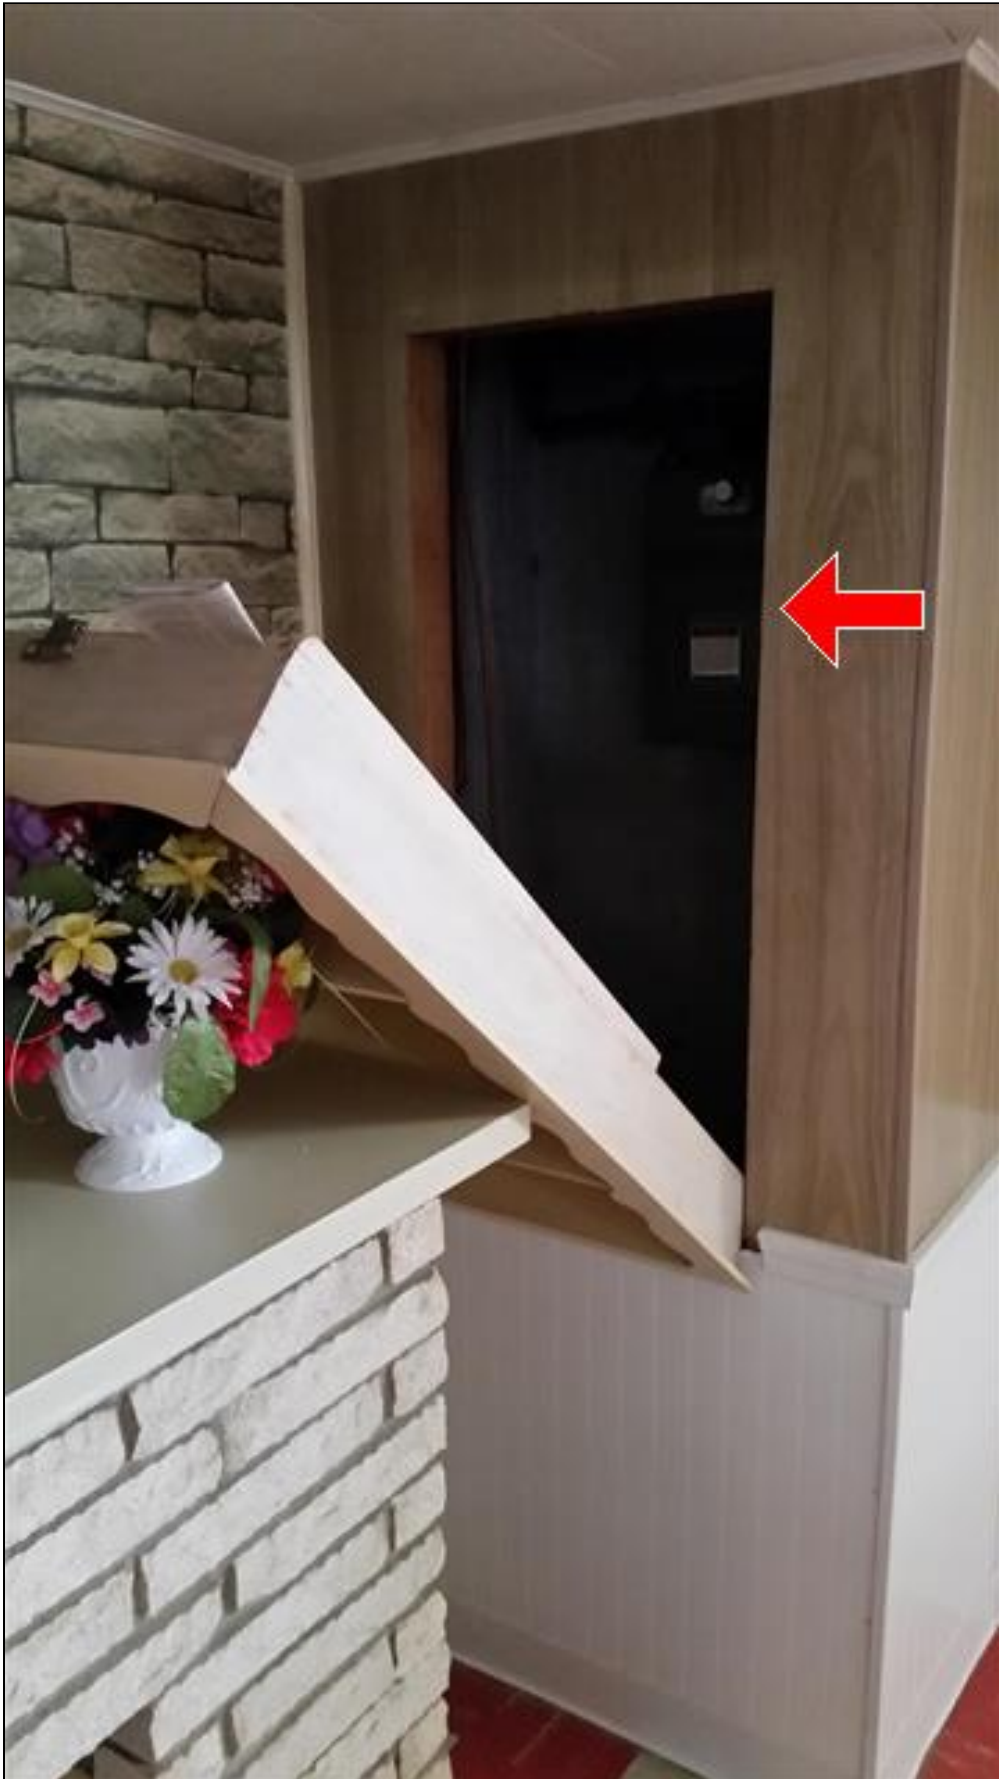
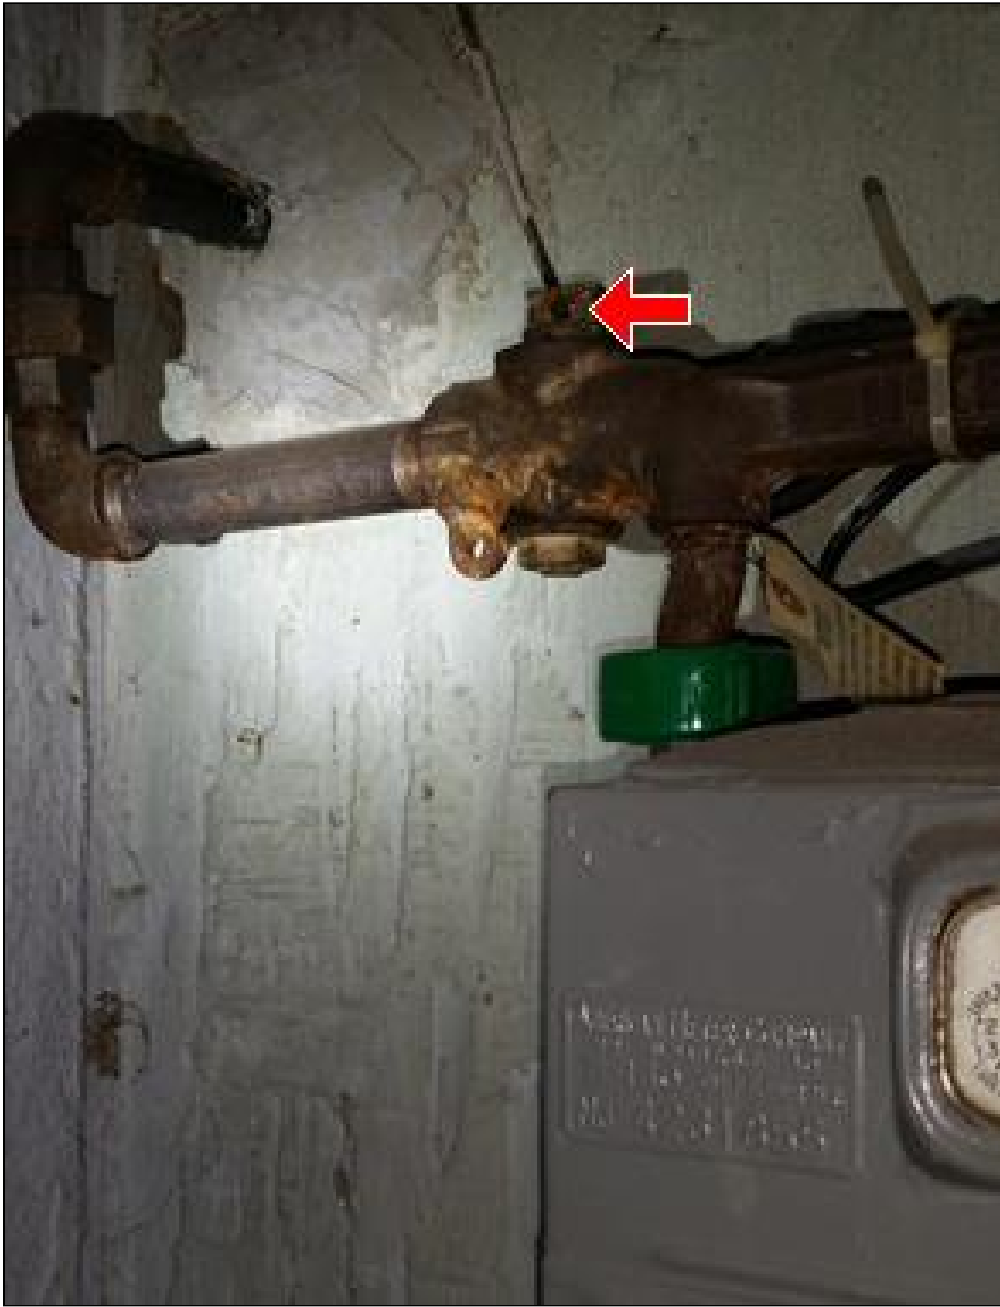
**5.1** Natural gas shut-off is located behind a "hidden-panel" in the basement wall. Pulling the shelf/panel outwards will expose the gas shut-off as seen in the picture.

5.1 Item 1(Picture) Natural gas shut-off is located behind a "hidden-panel"

5.1 Item 2(Picture) Natural gas shut-off.

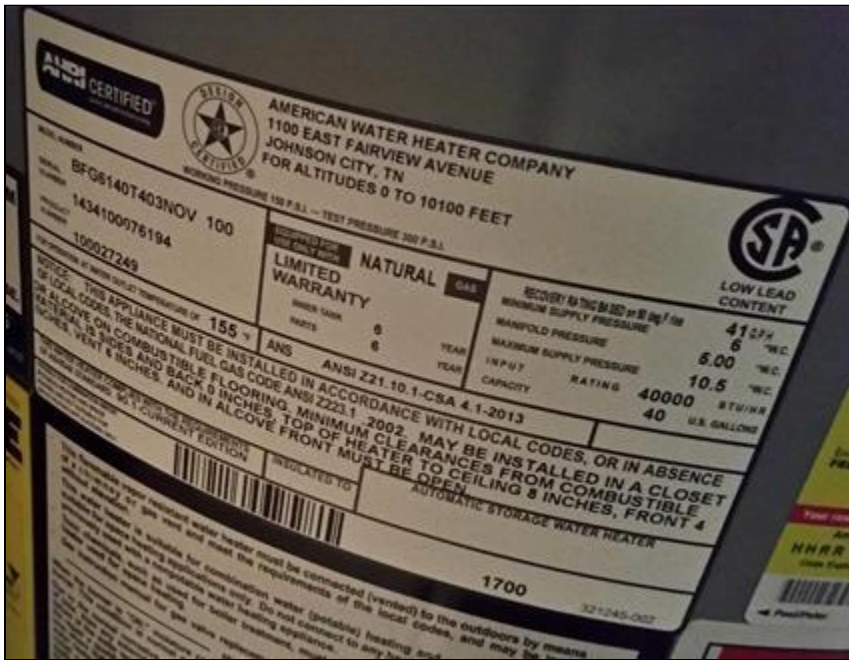
5.2 Water heater manufactured August 2014.

5.2 Item 1(Picture) Water heater info label.

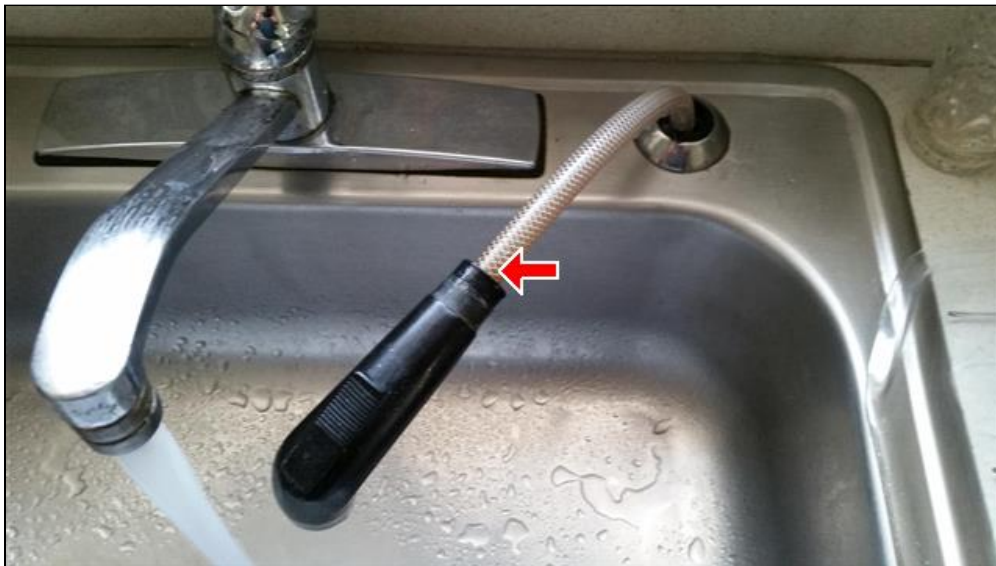
5.3 Item 1(Picture) Slight leak from kitchen sink spray attachment.

5.3 (1) Slight leak from kitchen sink spray attachment. Water may leak down the hose and collect under the sink. Inspector recommends replacement.

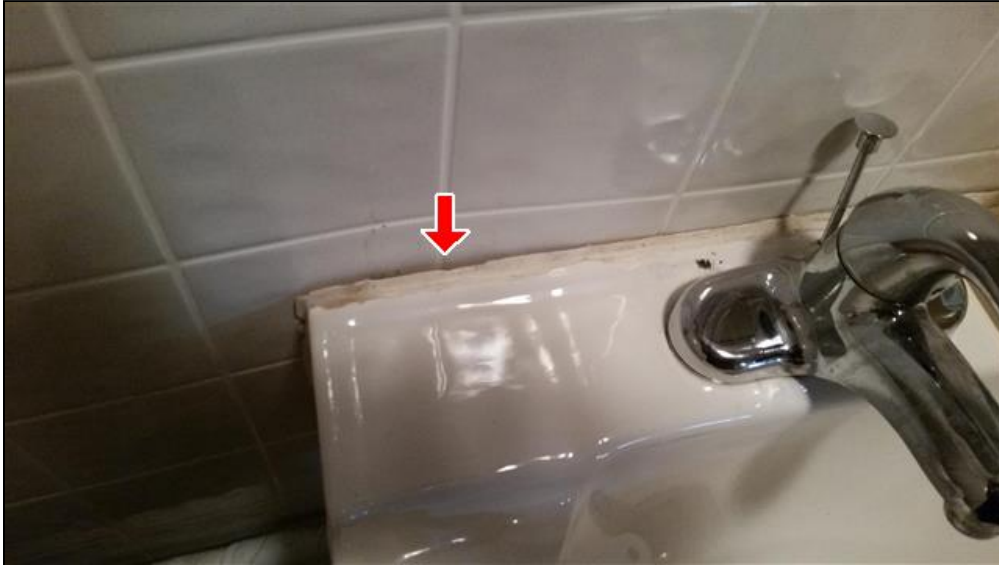
5.3 Item 2(Picture) Caulk bead behind basement bathroom sink is deteriorated.

(2) Caulk bead behind basement bathroom sink is deteriorated. Inspector recommends re-caulking to avoid water penetrating behind the sink.

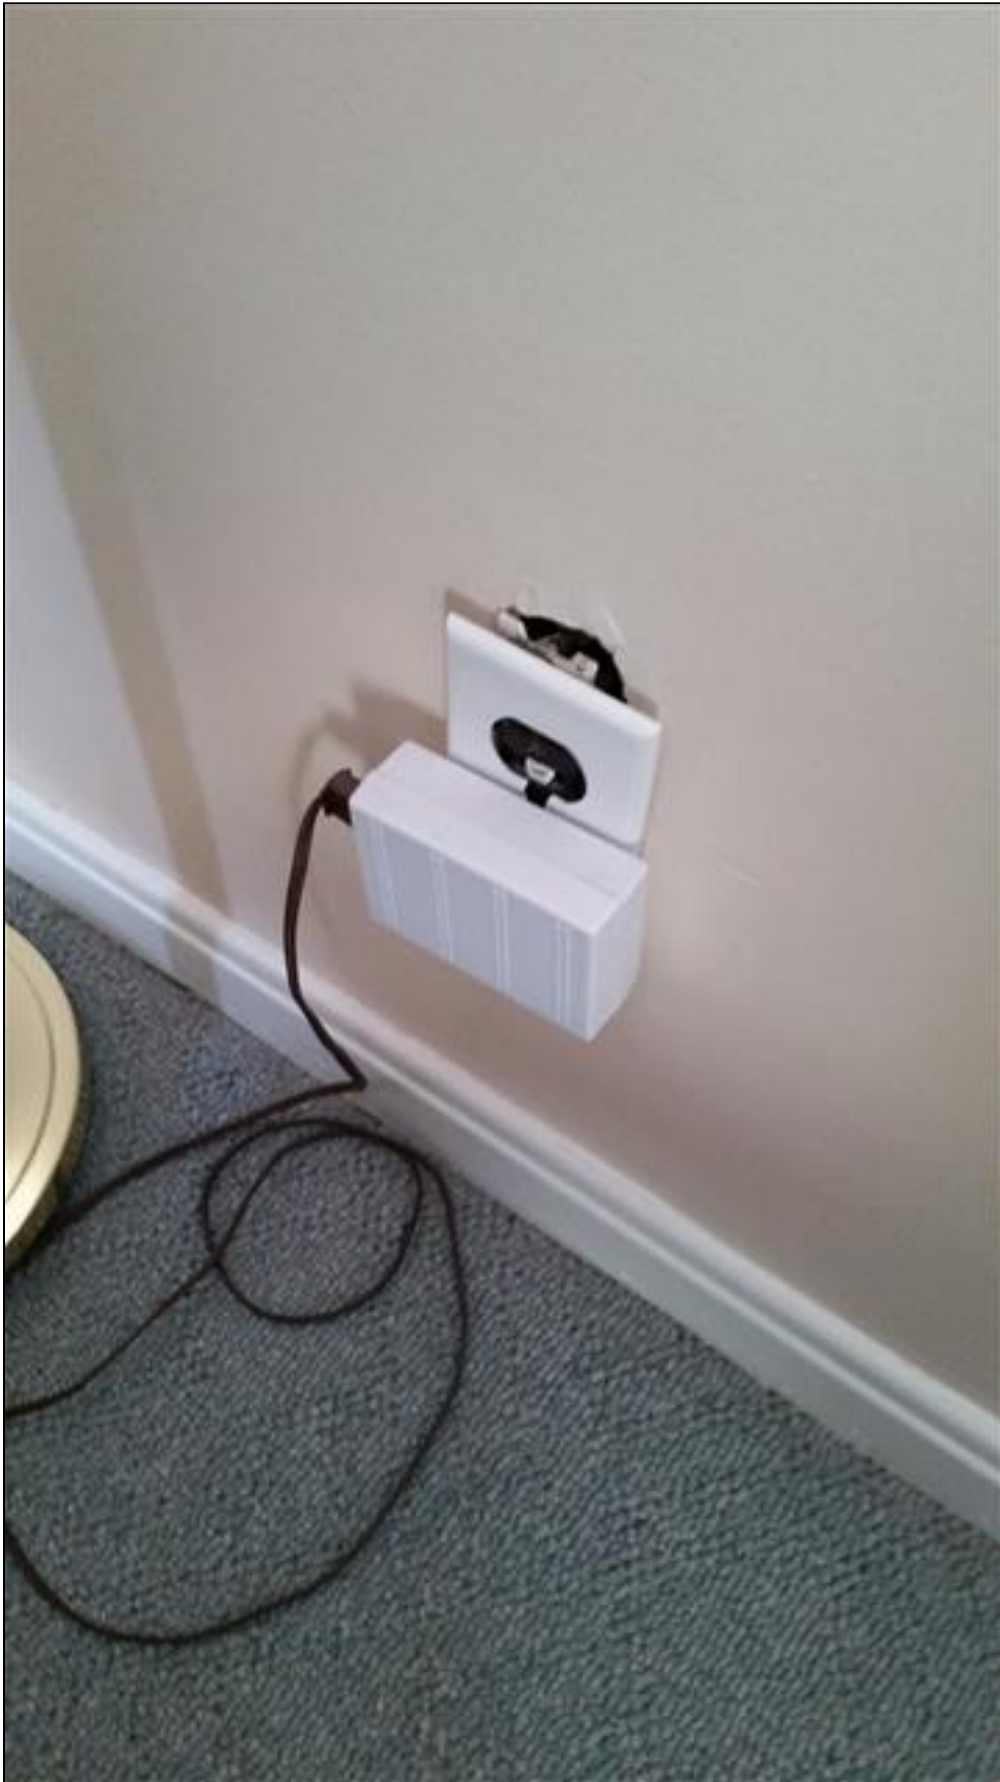
6.3 Item 1(Picture) Receptacle cover is broken.

**6.3** Receptacle cover is broken. Inspector recommends replacement.

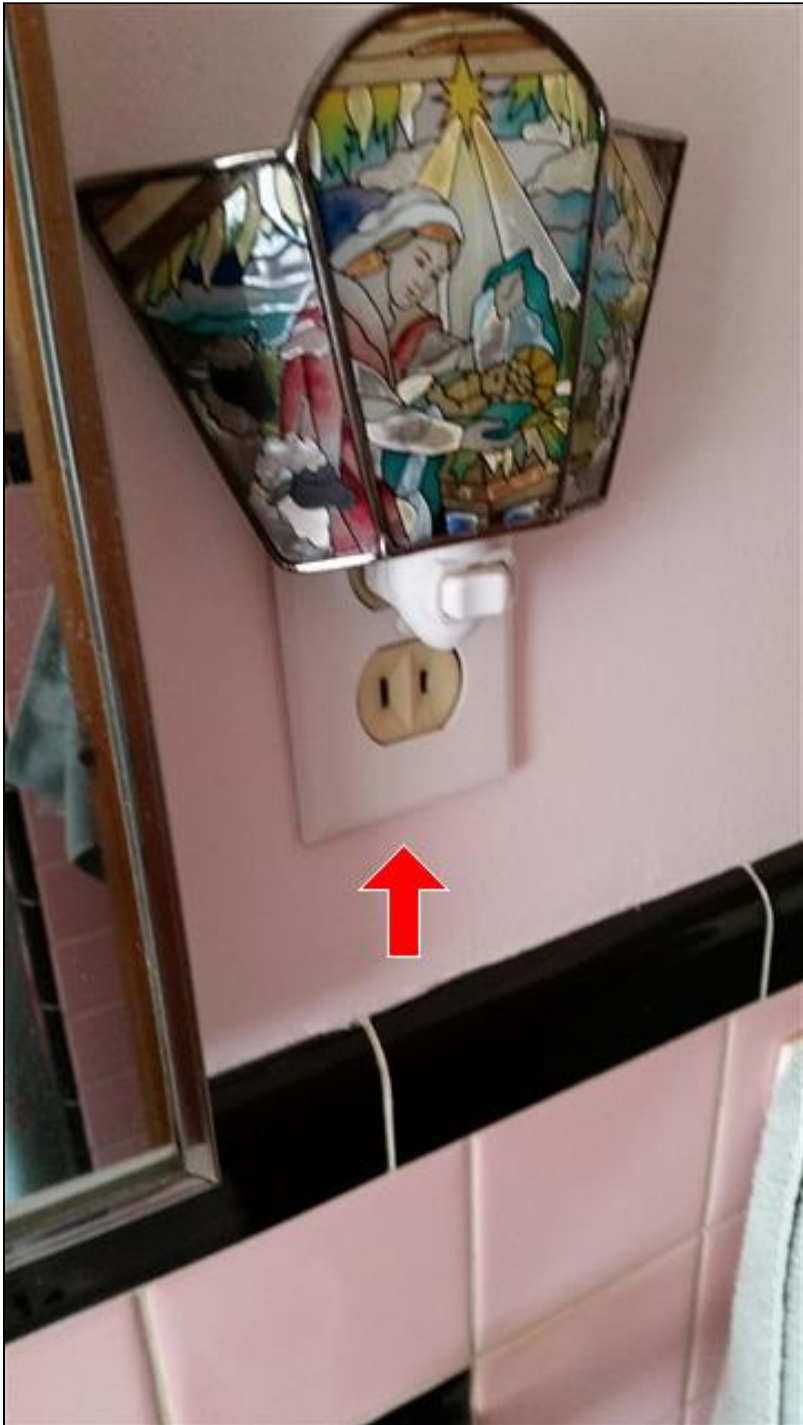
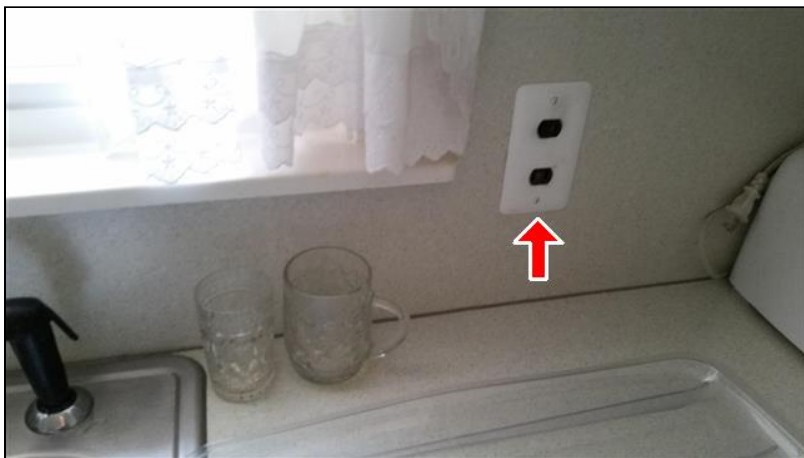
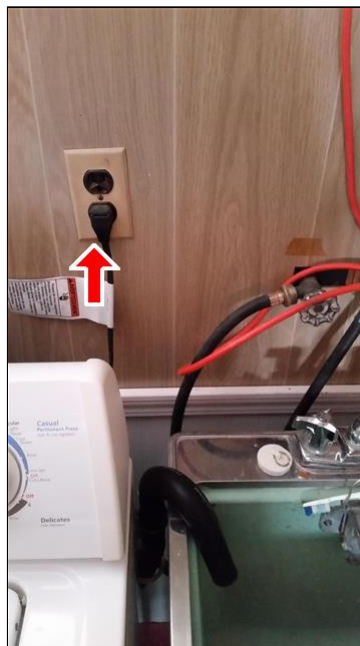
6.4 Item 1(Picture) Standard receptacle (not GFCI) too close to water source.

6.4 Item 2(Picture) Standard receptacle (not GFCI) too close to water source.

6.4 Item 3(Picture) Standard receptacle (not GFCI) too close to water source.

**6.4** Ground fault circuit interrupt protection outlets should be installed as replacements for any receptacles within 6 feet of interior plumbing.

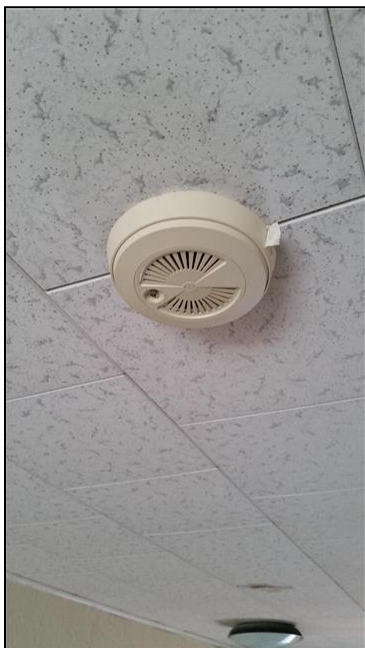
6.7 Item 1(Picture) Smoke detector in 2nd floor is an older model and should be replaced.

6.7 Smoke detector in 2nd floor is an older model and should be replaced. Smoke detectors should also be installed in each bedroom on the first floor.

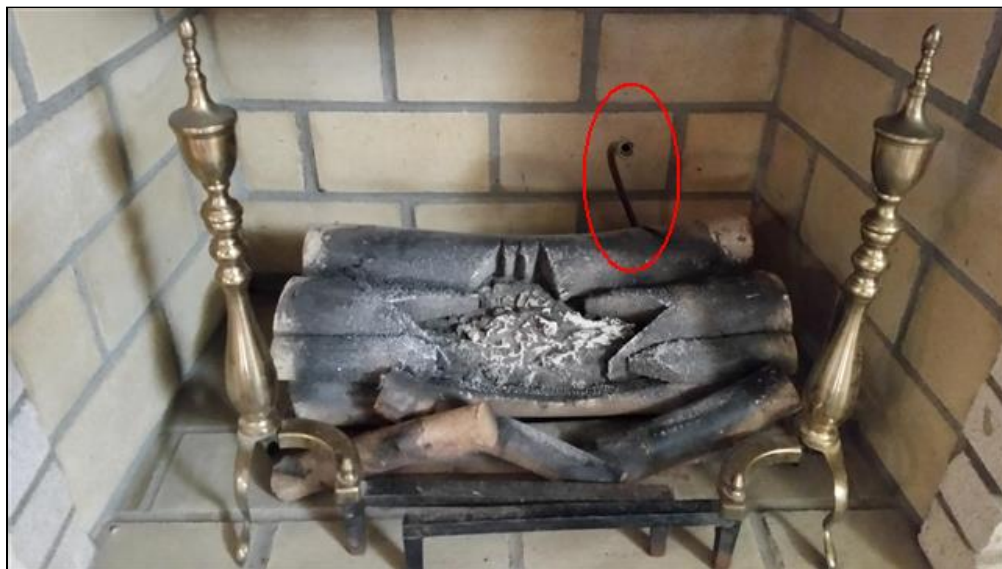
7.0 Item 1(Picture) Natural gas line is not correctly hooked up or positioned for fireplace use.

**7.0** Natural gas line is not correctly hooked up or positioned for fireplace use. Inspector recommends correct placement of gas line prior to operation.

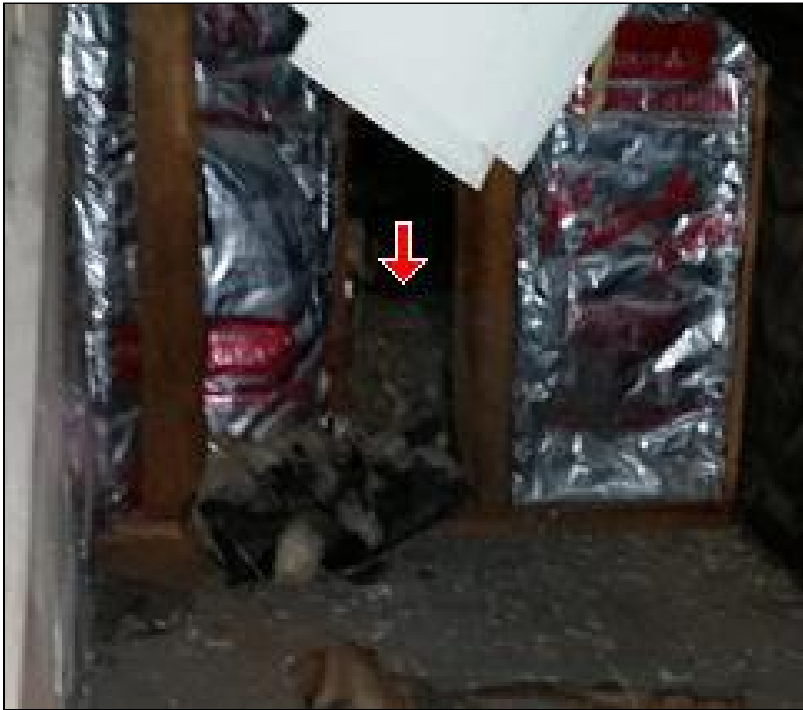
8.3 Item 1(Picture) Birds nest debris in the attic.

**8.3** Birds nest debris in the attic. Although there appear to be no current birds living in the attic, caution should be taken in removing this debris. It appears that the nest material was from a previous problem that was corrected by the placement of mesh wire screens over the gable vents.

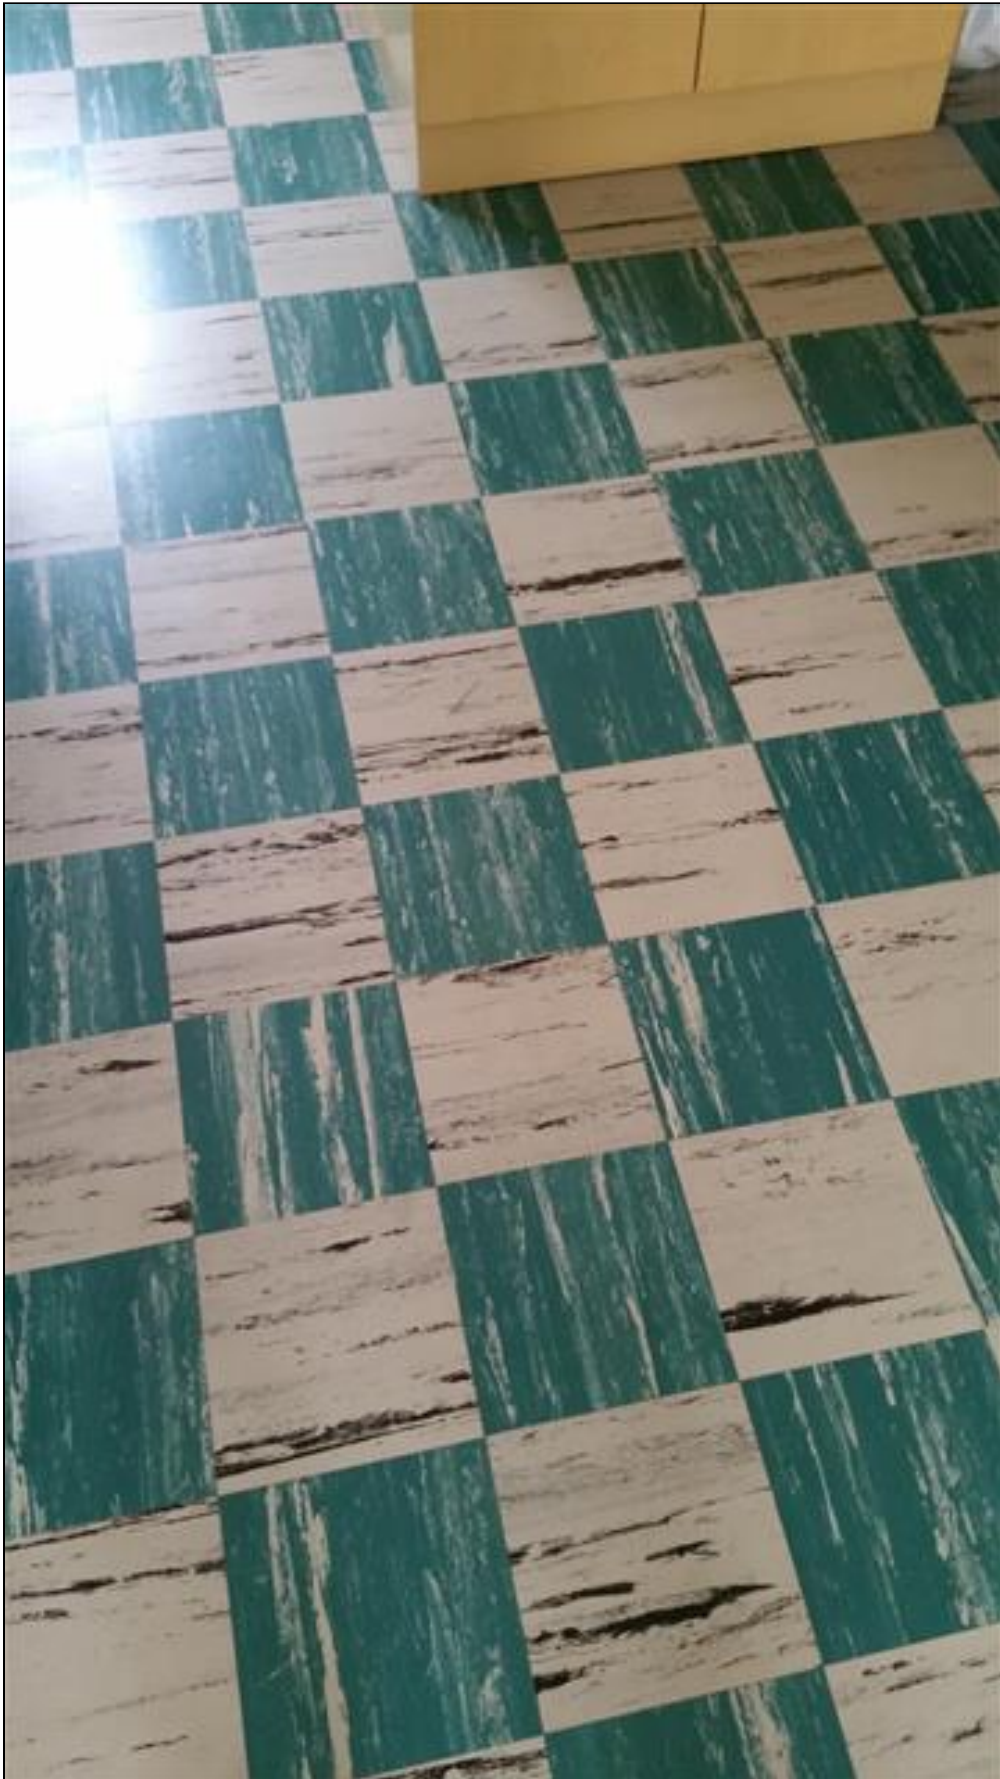
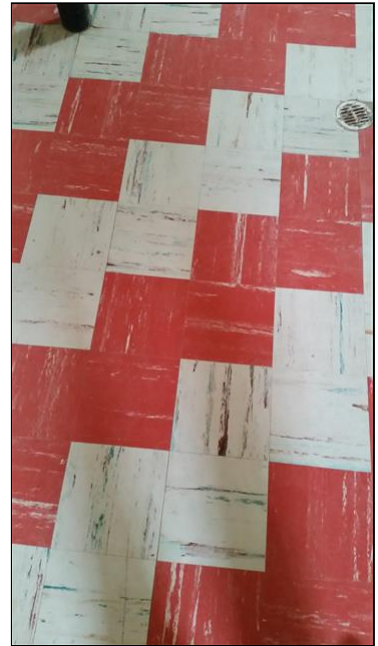
**9.2** Floor tile in 2nd floor and basement may be of the asbestos type. While harmless if left undisturbed, precautions should be taken if this tile is ever removed or replaced.

9.2 Item 1(Picture) Floor tile in 2nd floor may be of the asbestos type.

9.2 Item 2(Picture) Floor tile in basement may be of the asbestos type.

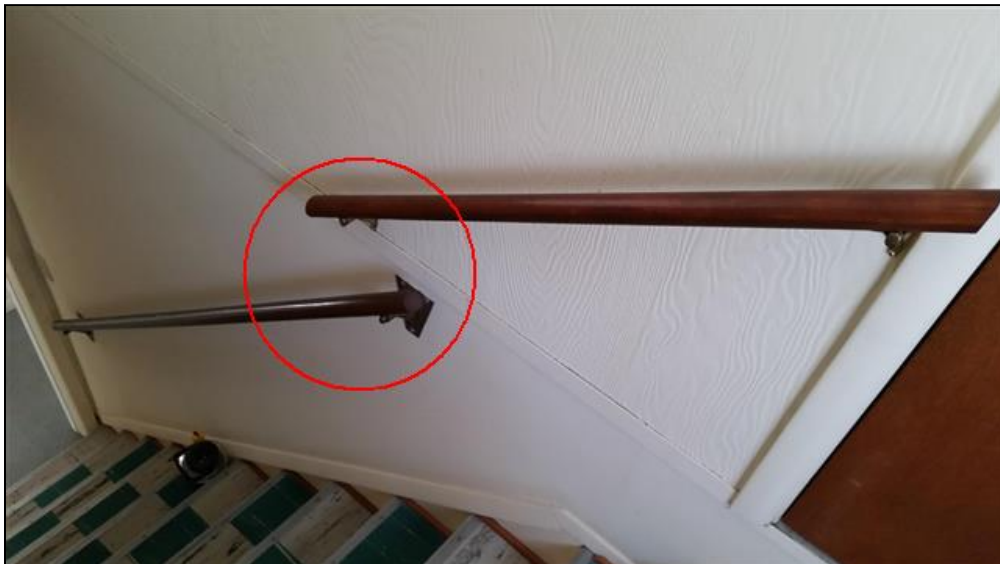
9.3 Item 1(Picture) Non-continuous railing to 2nd floor.

9.3 (1) Although the railing is sufficient, building code dictates that "handrails for stairways shall be continuous for the full length of the flight" of stairs. Future correction is recommended.

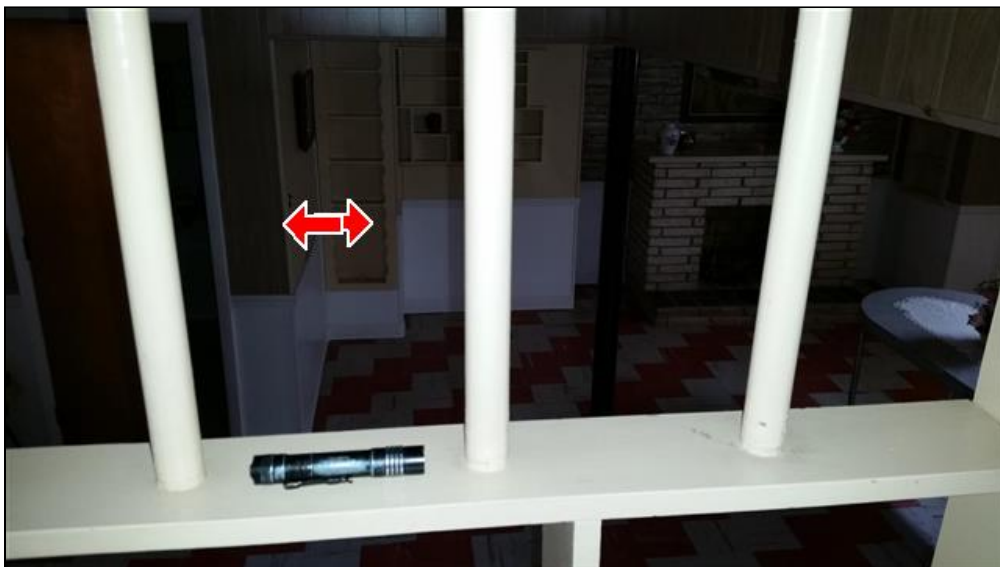
9.3 Item 2(Picture) Space between these baluster type rails on the basement stairs are greater than 4 inches apart.

(2) Space between these baluster type rails on the basement stairs are greater than 4 inches apart. This poses a child safety risk. Inspector recommends placement of paneling over the rails to close them in or other remediation to ensure child safety in the home.
