# Inspection Report

**Property Address:**  
123 Anystreet  
Hometown MI 44444

## Up Close Home Inspection

<b>Date:</b> 5/6/2015	<b>Time:</b> 01:00 PM	<b>Report ID:</b> 15-050601
<b>Property:</b> 123 Anystreet Hometown MI 44444	<b>Customer:</b> Mr. and Mrs. Joe Sample	<b>Real Estate Professional:</b> Bob Realtor Real Estate Company

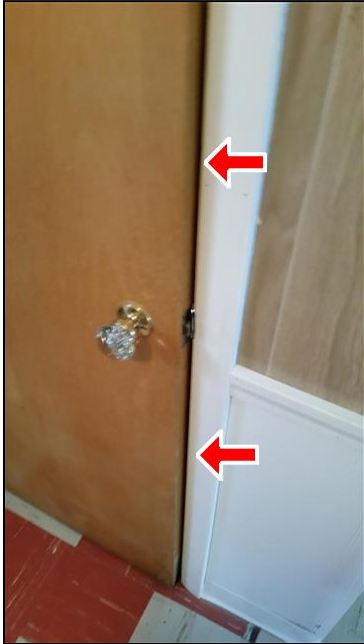
9.5 Item 1(Picture) Basement bathroom door does not close completely with pressure.

9.5 Basement bathroom door does not close completely with pressure. Inspector recommends adjustment of striker in door jam to ensure proper closing.

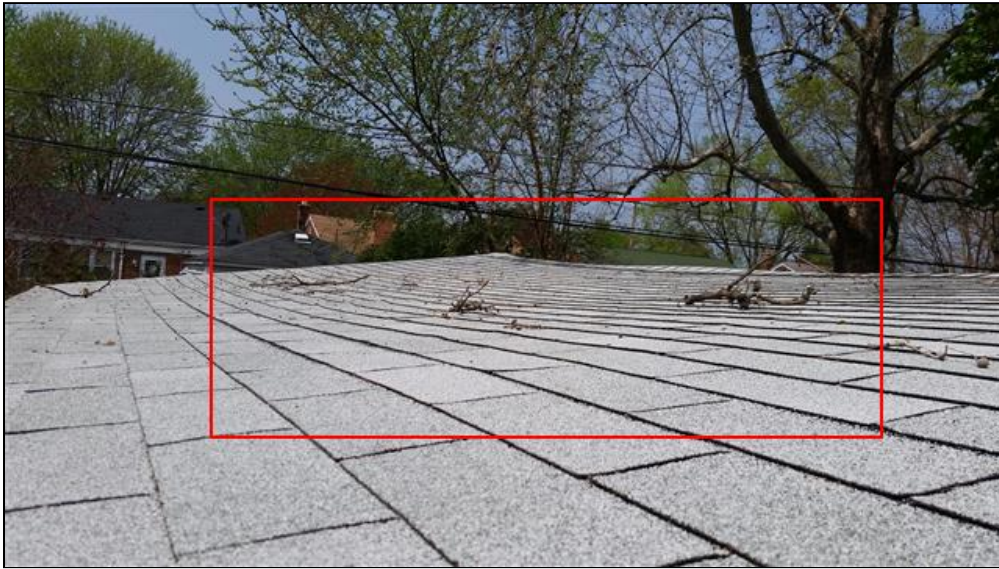
10.0 Item 1(Picture) Area of garage roof is slightly concave.

10.0 Area of garage roof is slightly concave. Although no moisture penetration is apparent, future correction may prevent further problems.
